The Secretary of the Interior's Standards
for the Treatment of Historic Properties

with Guidelines for
Preserving, Rehabilitating
Restoring & Reconstructing
Historic Buildings

Kay D. Weeks and Anne E. Grimmer

U.S. Department of the Interior
National Park Service
Cultural Resource Stewardship and Partnerships
Heritage Preservation Services
Washington, D.C.
1995

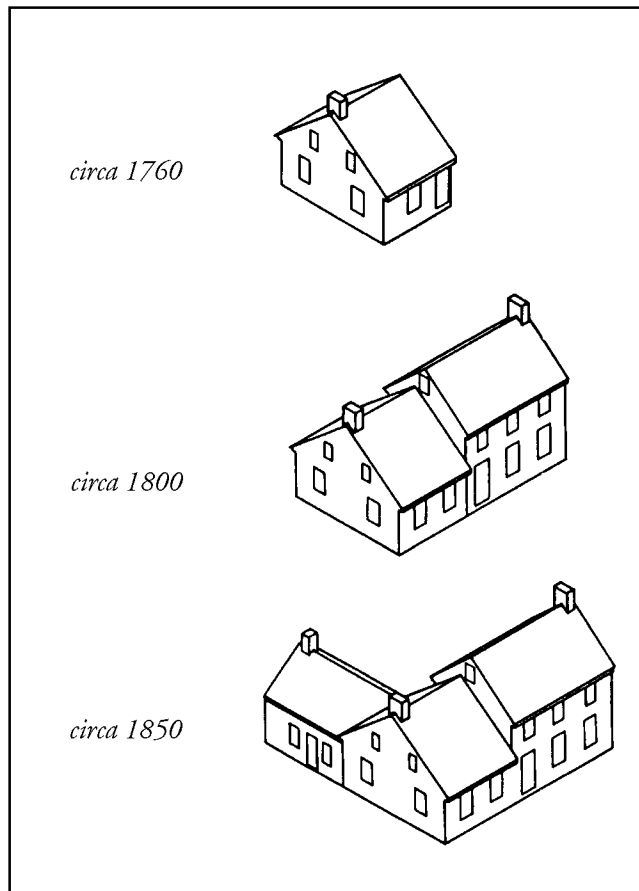
This three-part drawing shows the evolution of a farm house over time. Such change is part of the history of the place and is respected within the treatment, Preservation. Drawing: Center for Historic Architecture and Engineering, University of Delaware (adapted from Preservation Brief 35: Understanding Old Buildings).

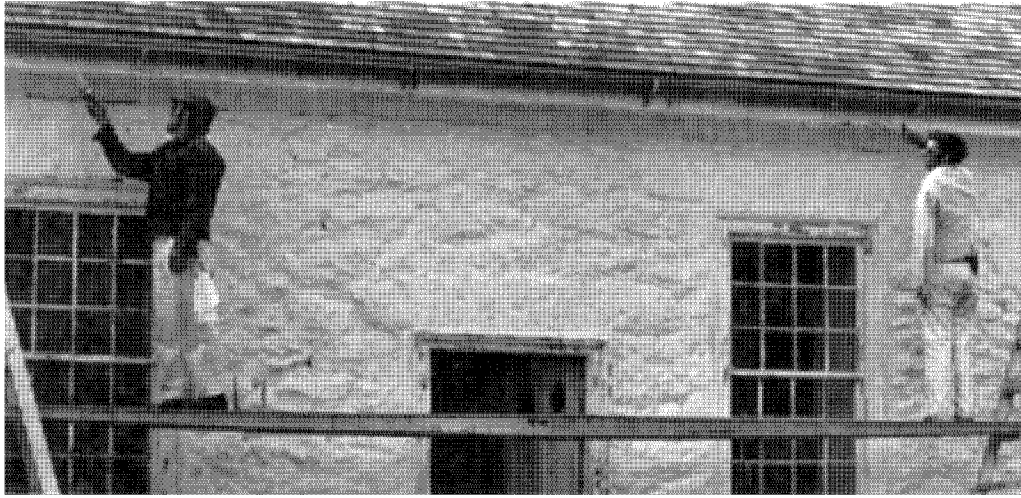
Adequate protection and maintenance of a historic building is an ongoing commitment. Here, two workers are priming and repainting exterior stone and wood trim. If surface treatments are neglected, more extensive repair and replacement will be required. Each loss further undermines a building's historic integrity.

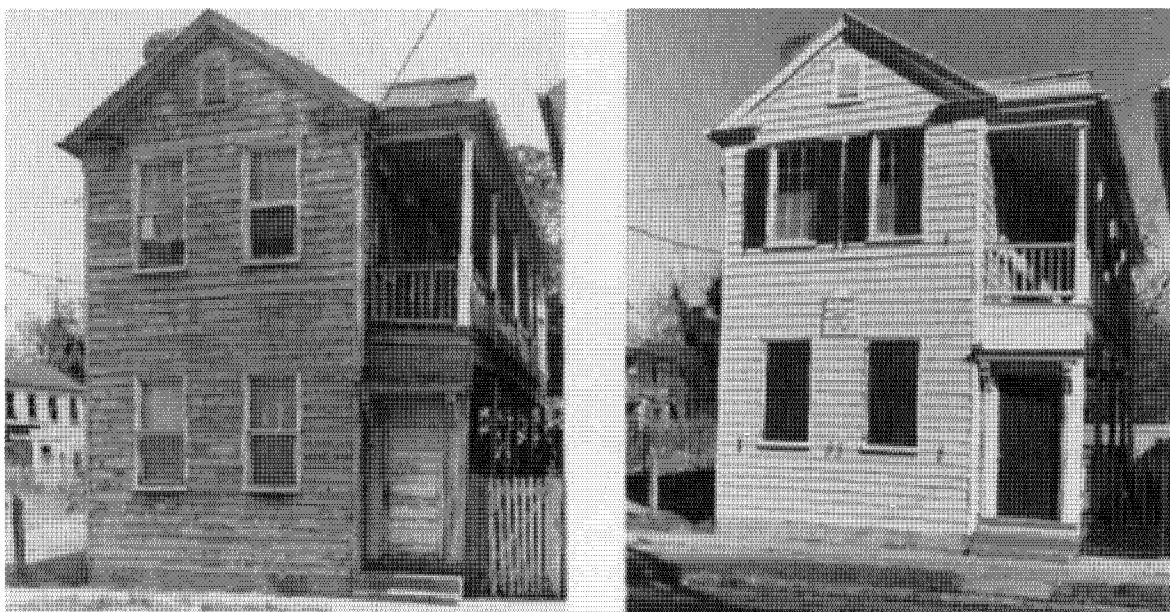
Maximizing retention of historic materials and features is the primary goal of Preservation as demonstrated here in these “before” and “after” photographs. Aside from some minor repairs and limited replacement of deteriorated material, work on this house consisted primarily of repainting the wood exterior. Photos: Historic Charleston Foundation.

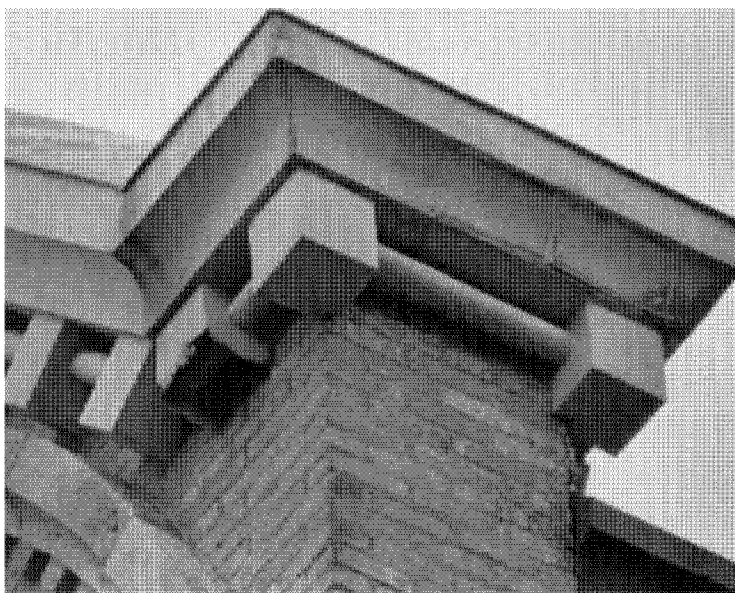
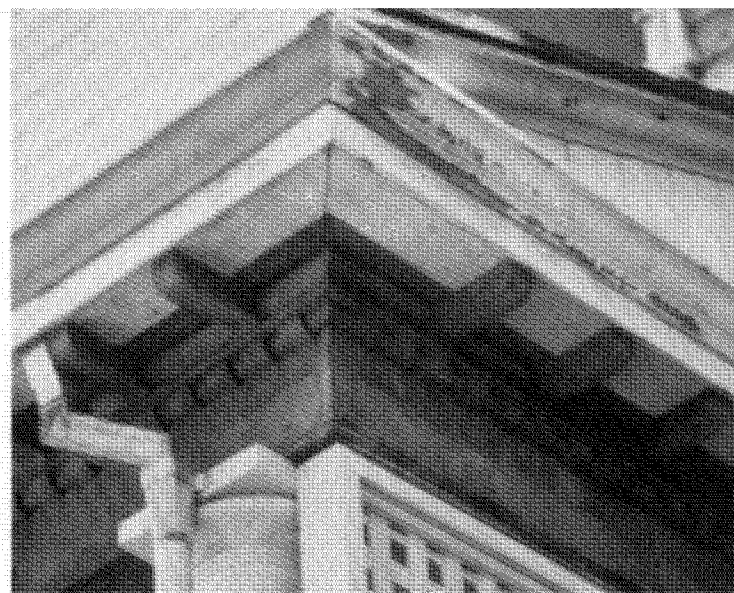
Two examples of “limited replacement in kind” point out an appropriate scope of work within the treatment, Preservation. (a) One metal modillion that has sustained damage from a faulty gutter will need to be replaced; and (b) targeted repairs to deteriorated wood cornice elements (fascia board and modillions) meant that most of the historic materials were retained in the work.

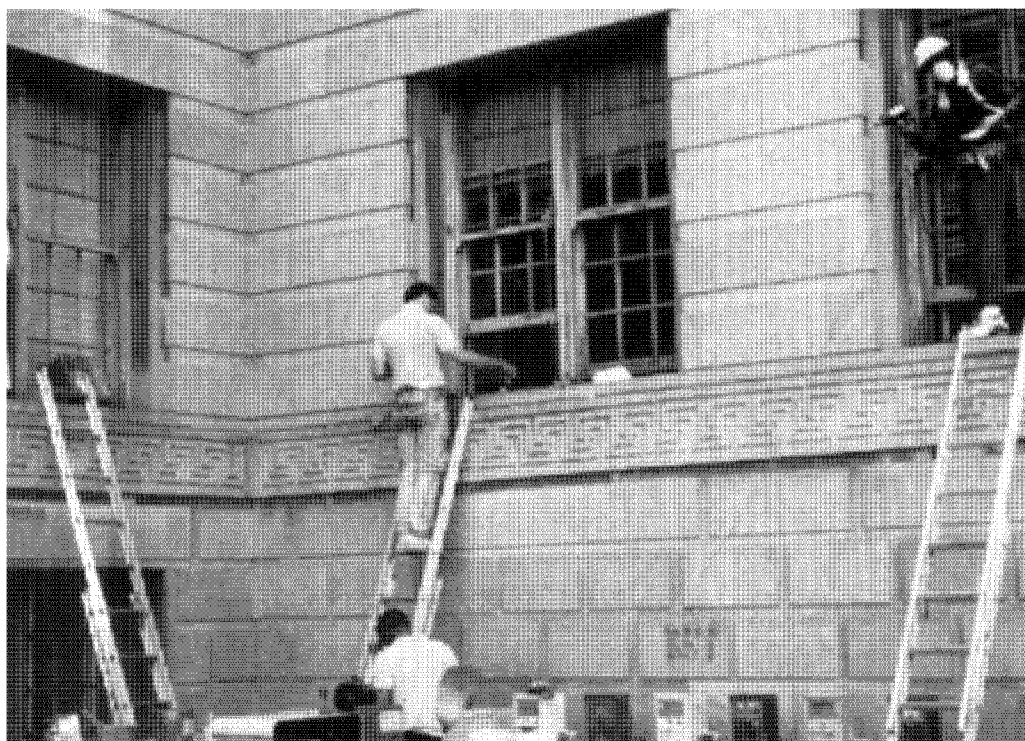
Preserving a building's historic windows generally involves scraping, sanding, and re-painting. While some repair work will most likely be undertaken within the scope of work on this institutional building, replacement of the window units is usually not an appropriate Preservation treatment. Photo: Chuck Fisher.

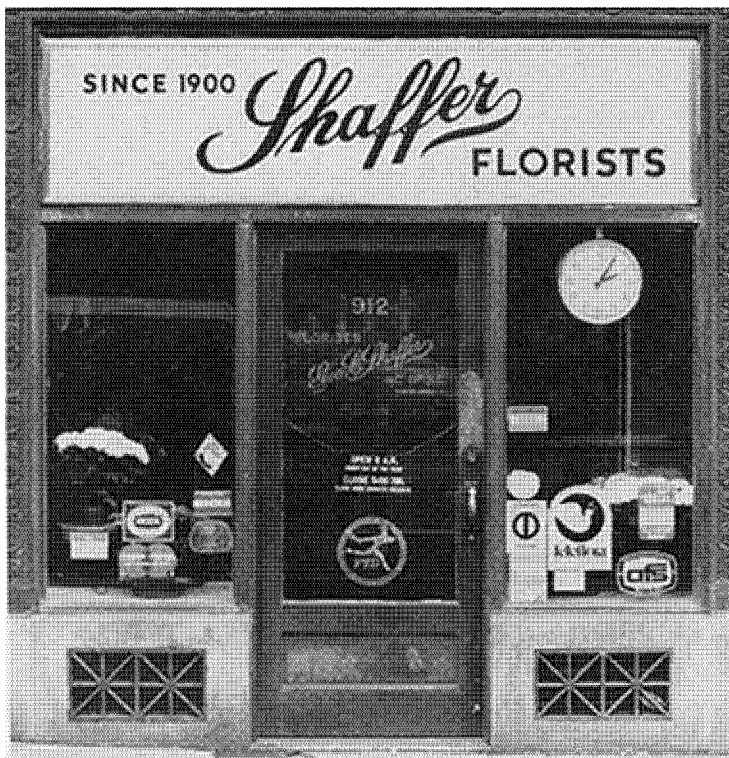
The original form and features of this 1920s storefront have been retained through Preservation. Photo: David W. Look, AIA.

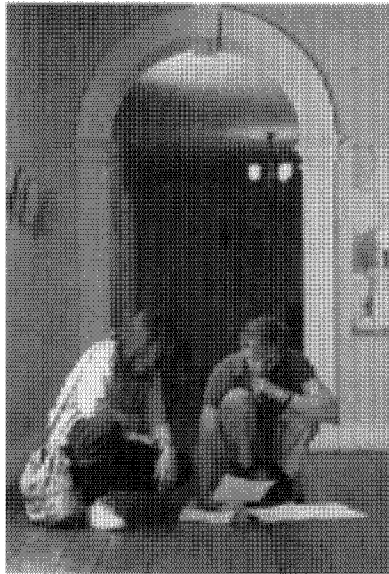
Careful documentation of a building's physical condition is the critical first step in determining an appropriate level of intervention. (a) This may include relating the historical research to existing materials and features; or (b) documenting a particular problem such as this cracked ceiling. Photo (a): Jean E. Travers; Photo (b): Lee H. Nelson, FALA.

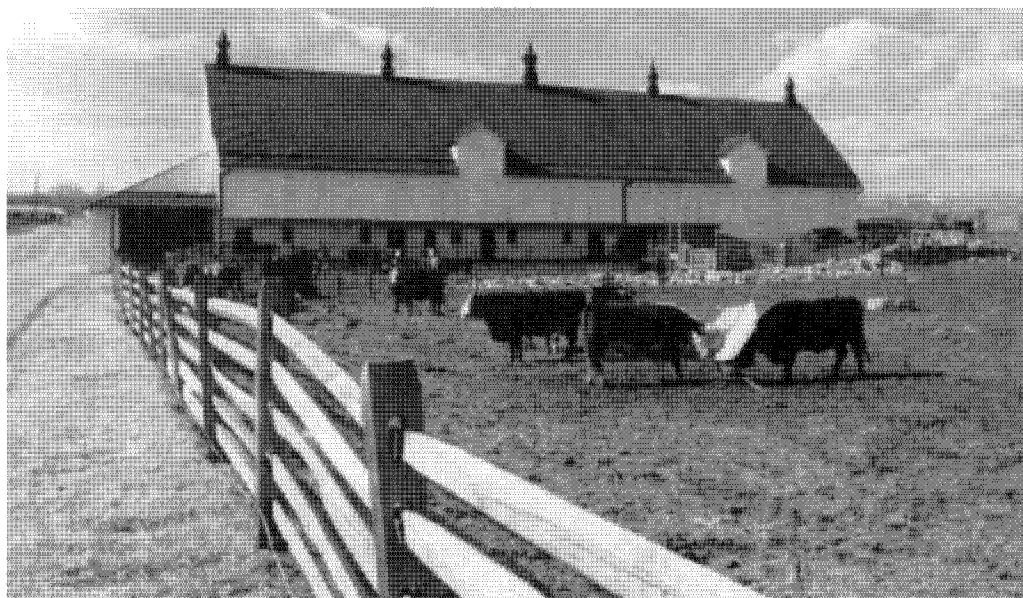
The goal of Preservation is to retain the historic form, materials, and features of the building and its site as they have changed—or evolved—over time. This bank barn was built in the 1820s, then enlarged in 1898 and again in 1914. Today, it continues its role as a working farm structure as a result of sensitive preservation work. This included foundation re-grading; a new gutter system; structural strengthening; and replacement of a severely deteriorated metal roof. Photo: Jack E. Boucher, HABS.

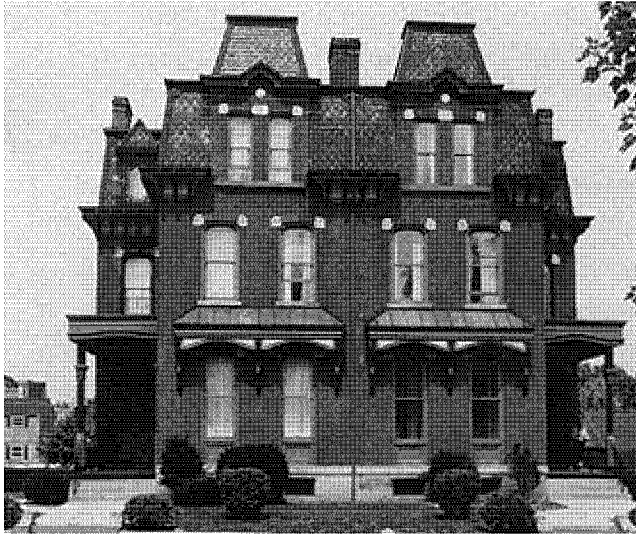
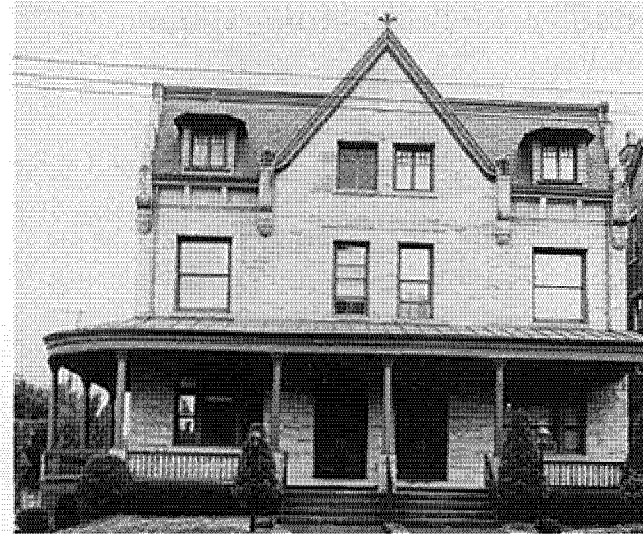
Originally built as single-family, semi-detached duplexes, these houses were rehabilitated for a new use as rental apartments. While some alteration to non-significant interior features and spaces was necessary in each one, the exteriors were essentially preserved. Photos: Mistick, Inc.

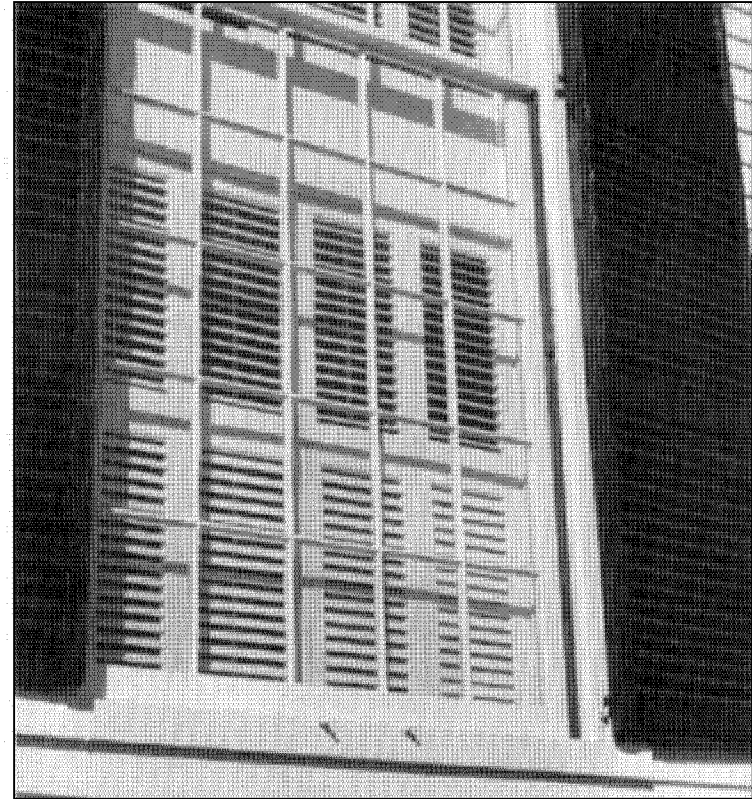
According to the Standards for Rehabilitation, existing historic materials should be protected, maintained and repaired. In an exemplary project, the windows and shutters of this historic residence were carefully preserved.

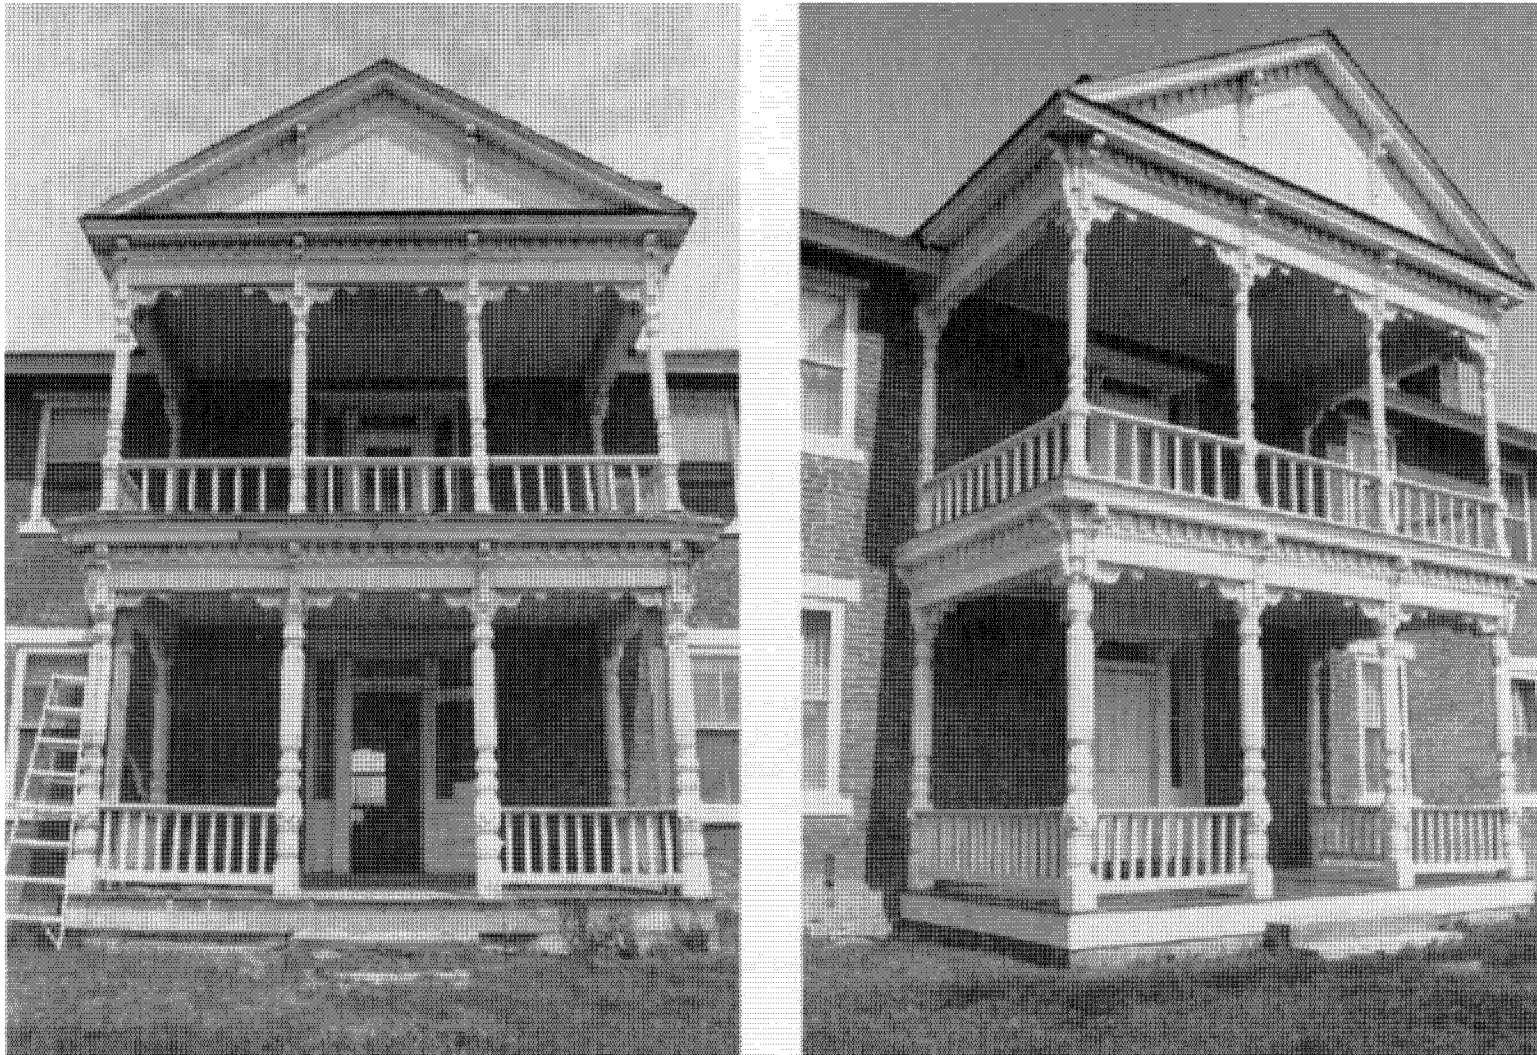
In Rehabilitation, deteriorated features should be repaired, whenever possible, and replaced when the severity of the damage makes it necessary. Here, a two-story porch is seen prior to treatment (left). The floor boards are rotted out and the columns are in a state of collapse, supported only by crude, temporary shafts. Other components are in varying stages of decay. Appropriate work on the historic porch (right) included repairs to the porch rails; and total replacement of the extensively deteriorated columns and floor boards. Some dismantling of the porch was necessary.

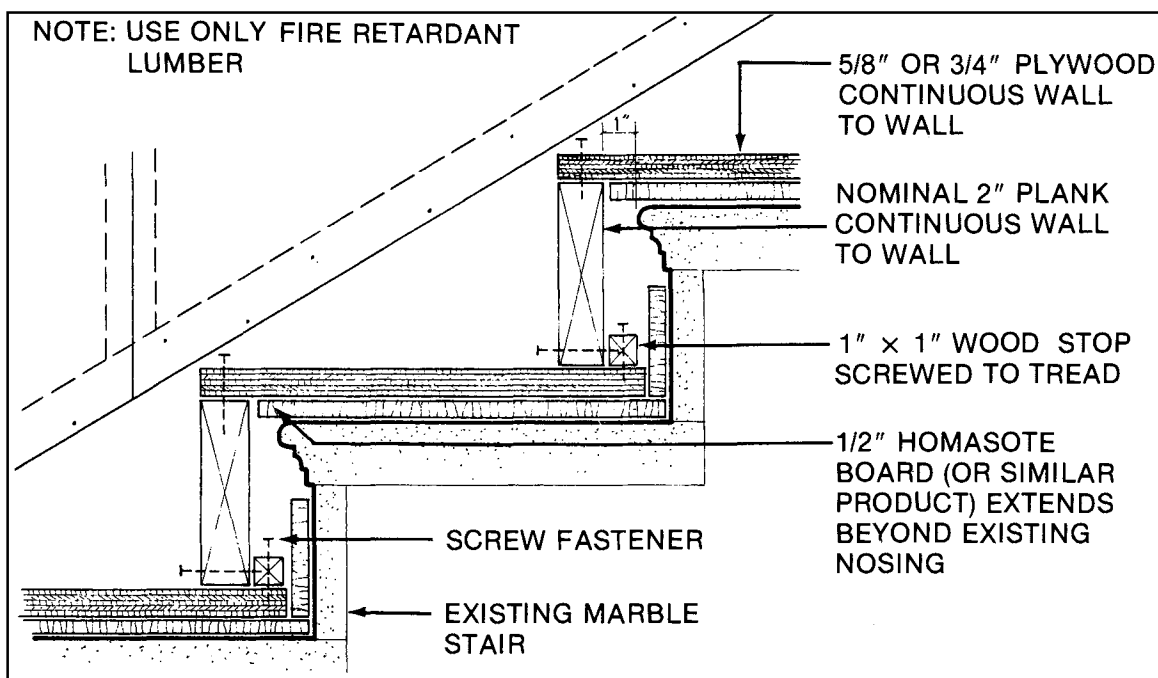
Historic features that characterize a building should always be protected from damage during rehabilitation work. The drawing shows how a resilient, temporary stair covering was applied over the existing marble staircase. Drawing: National Park Service staff, based on material originally prepared by Emery Roth and Sons, P.C.

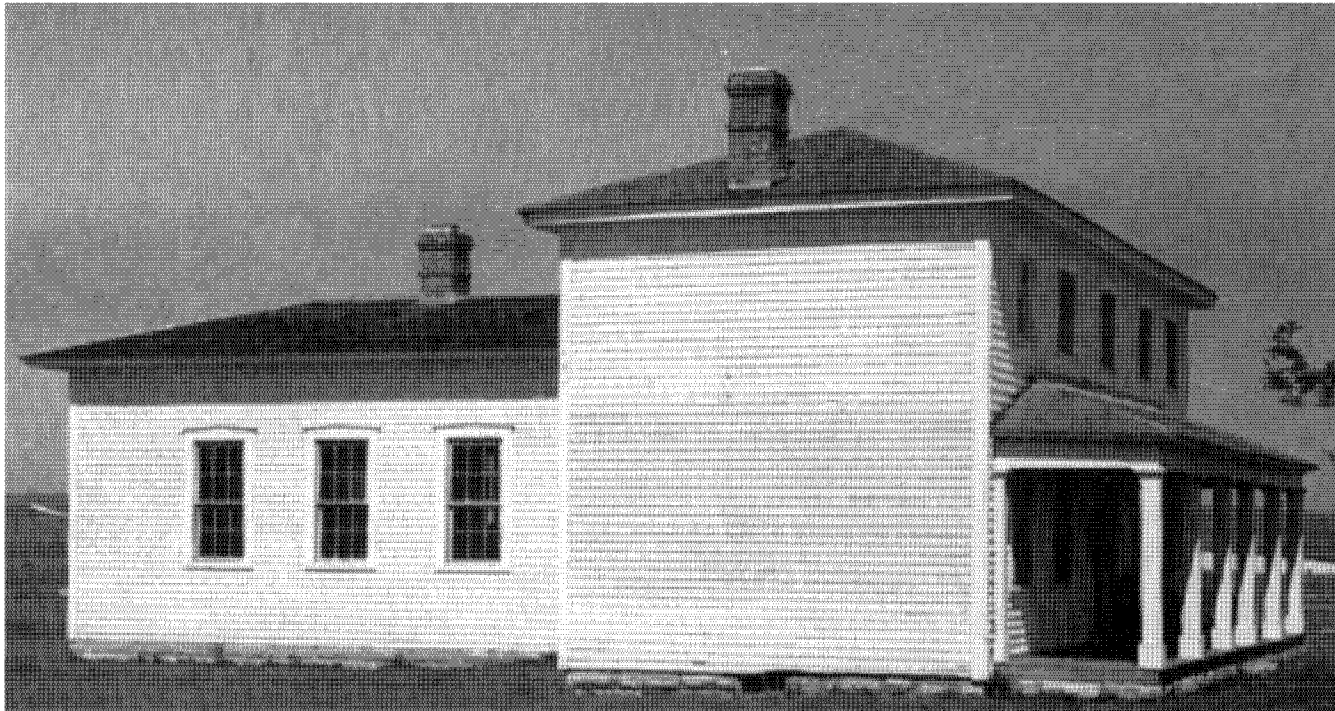
In a project at Fort Hays, Kansas, the wood frame officers' quarters were restored to the late 1860s—their period of significance. This included replacing a missing kitchen ell, chimneys, porch columns, and cornice, and closing a later window opening in the main block. The building and others in the museum complex is used to interpret frontier history.

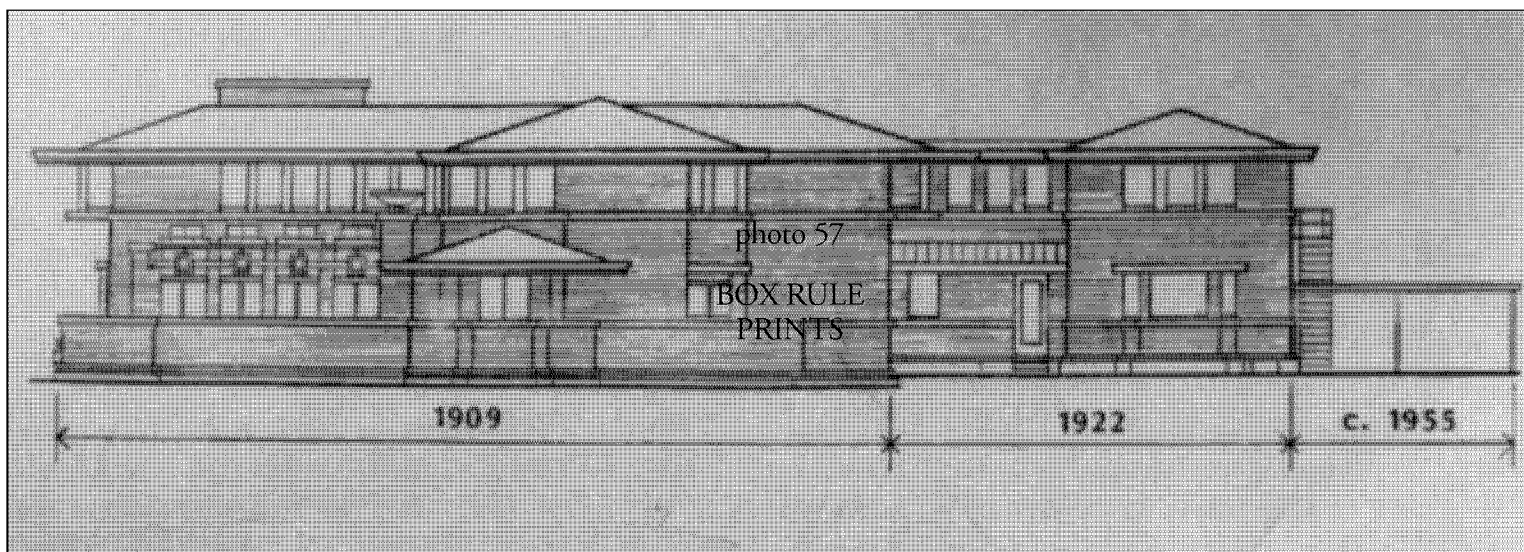
The Meyer May House in Grand Rapids, Michigan, was designed by Frank Lloyd Wright and built in 1909. In 1922, May added to the house for an expanding family. After the May occupancy, the house was altered for use as apartments, with a carport added in 1955. In the 1980s restoration, the Wright's original design was deemed more significant than May's later changes, and, as a result, the additions were removed and the house returned to its 1909 appearance. Drawing: Martha L. Werenfels, AIA.

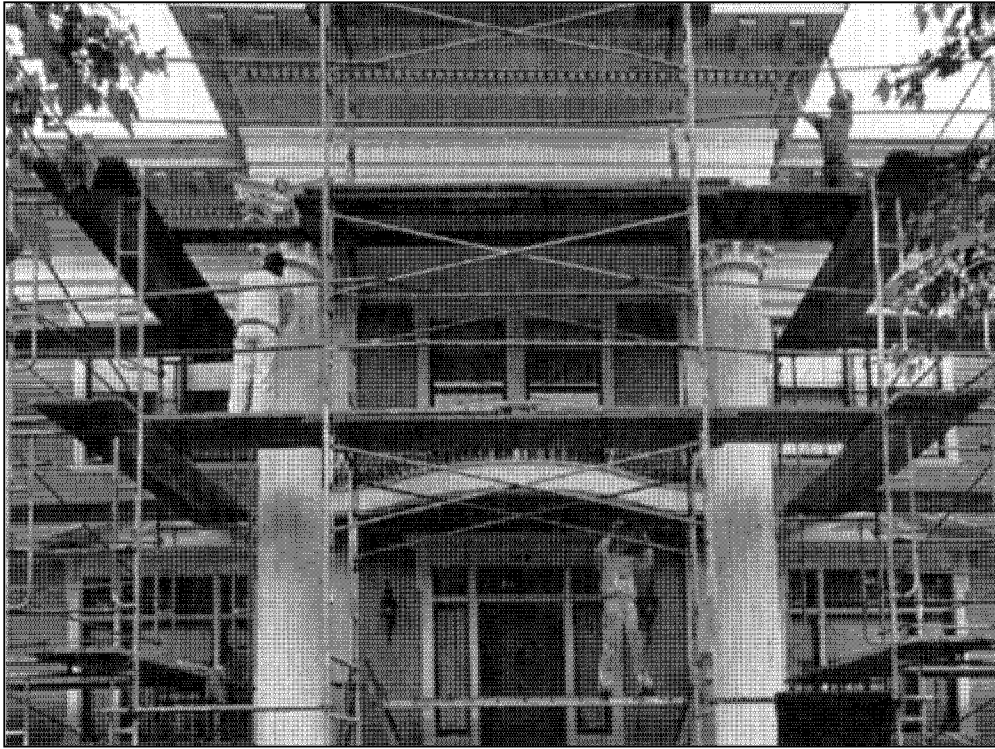
Ongoing work at this house focuses on the maintenance and repair of exterior wood features from the restoration period. After scraping and sanding, the wood was painted in colors documented to the Restoration period. Photo: ©Mary Randlett, 1992.

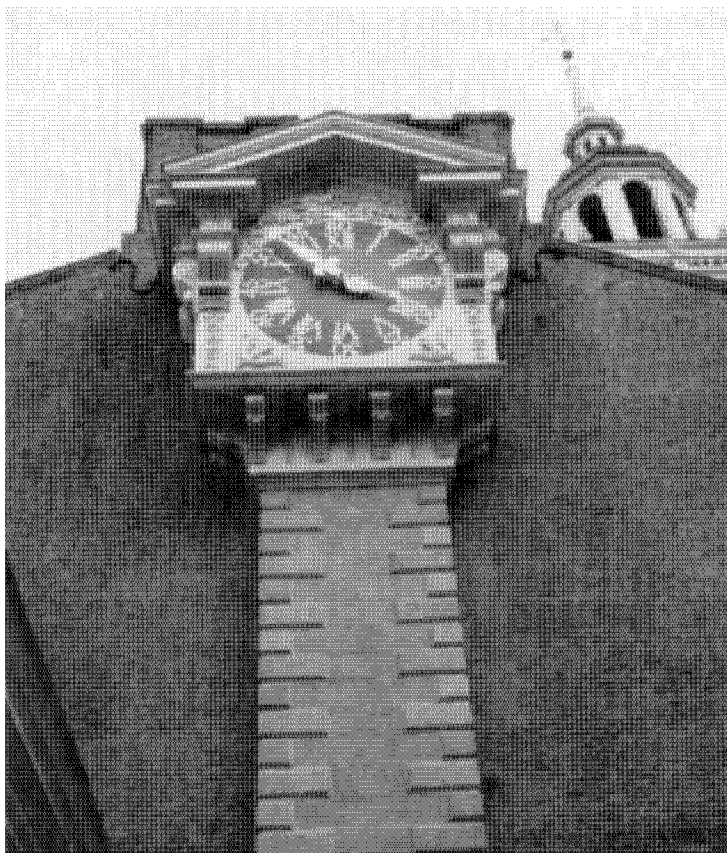
The Standards for Restoration call for the repair of existing features from the restoration period as well as the re-creation of missing features from the period. In some instances, when missing features are replaced, substitute materials may be considered if they convey the appearance of the historic materials. In this example at Philadelphia's Independence Hall, the clock was re-built in 1972-73 using cast stone and wood with fiberglass and polyester bronze ornamentation. Photo: Lee H. Nelson, FAIA.

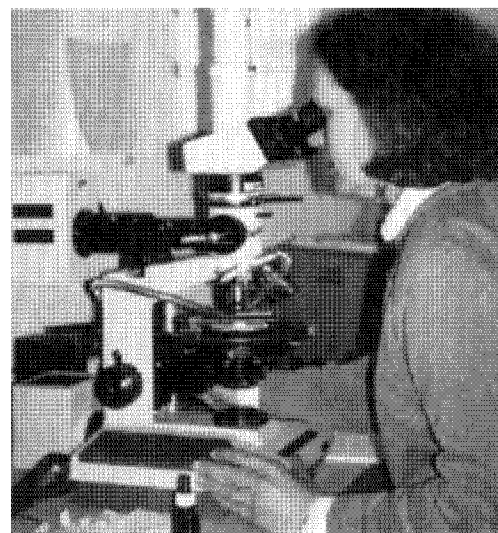
A complete paint investigation often needs to be conducted during Restoration. Paint samples are carefully collected onsite. In the laboratory, an ultra violet light is used to identify pigment and binding media. Paint samples are then photographed. Physical evidence documented through laboratory research provides a sound basis for an accurate restoration of painted finishes, such as the complex stencilling pictured here. Photo left: Courtesy, Alexis Elza; Photo right: Courtesy, Andrea Gilmore.

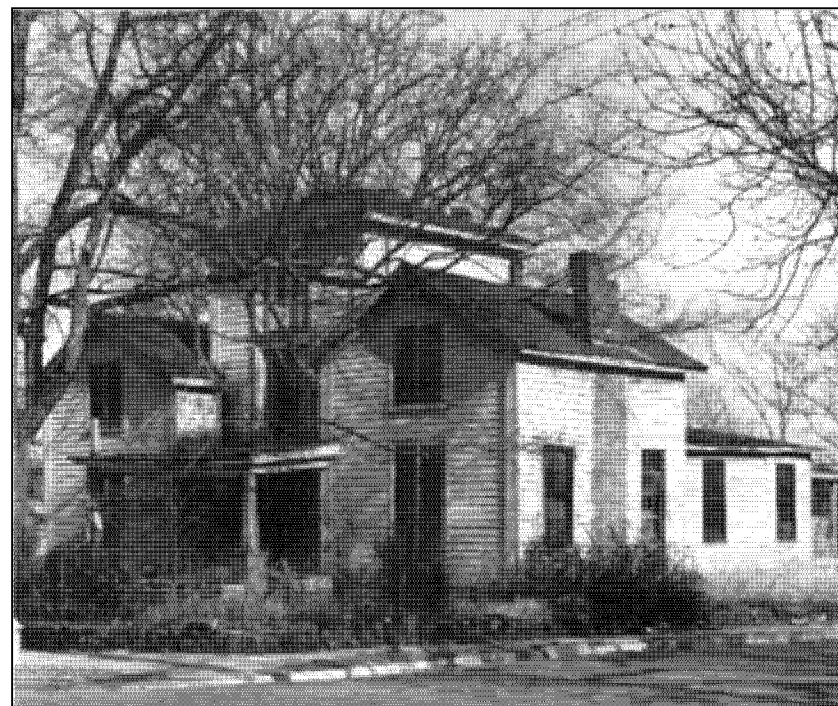
This ca. 1900 photograph (left) would be invaluable to guide restoration of the deteriorated house (right) to its documented earlier appearance, complete with decorative trim, shutters, polychromed exterior, and fencing. Photos: Courtesy, North Carolina Department of Archives and History.

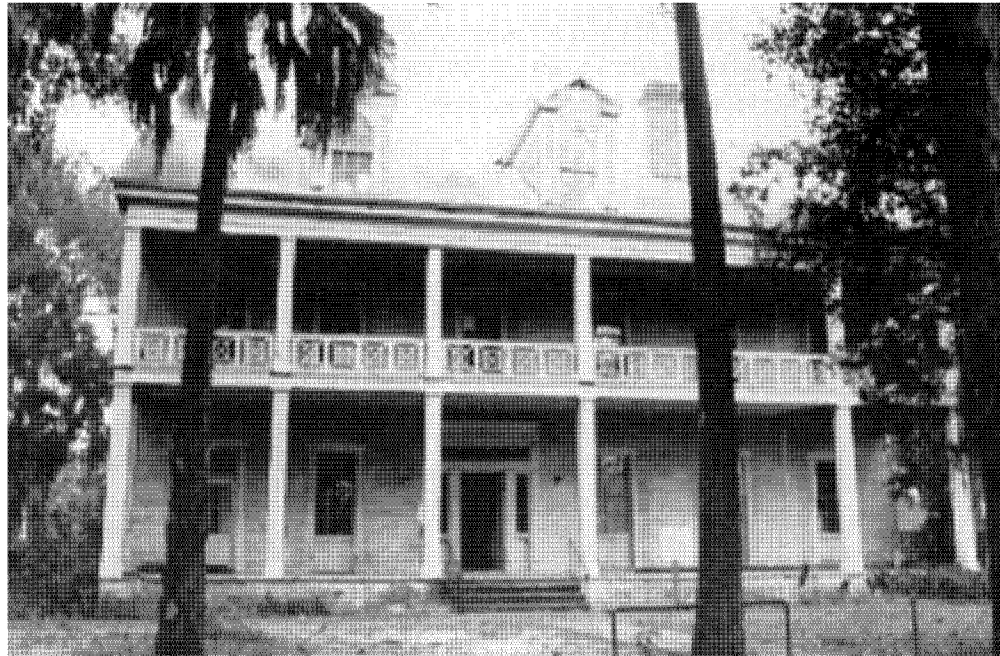
The Bronson-Mulholland House in Palatka, Florida, ca. 1845, is shown (a) before and (b) after the treatment, Restoration. Over the years the east (far right) side of the veranda had been filled in as a sixth bay. During the restoration, this later infill was removed and the east veranda, together with its flooring, stairs, and foundation, restored. Photo: City of Palatka, Community Development Department.

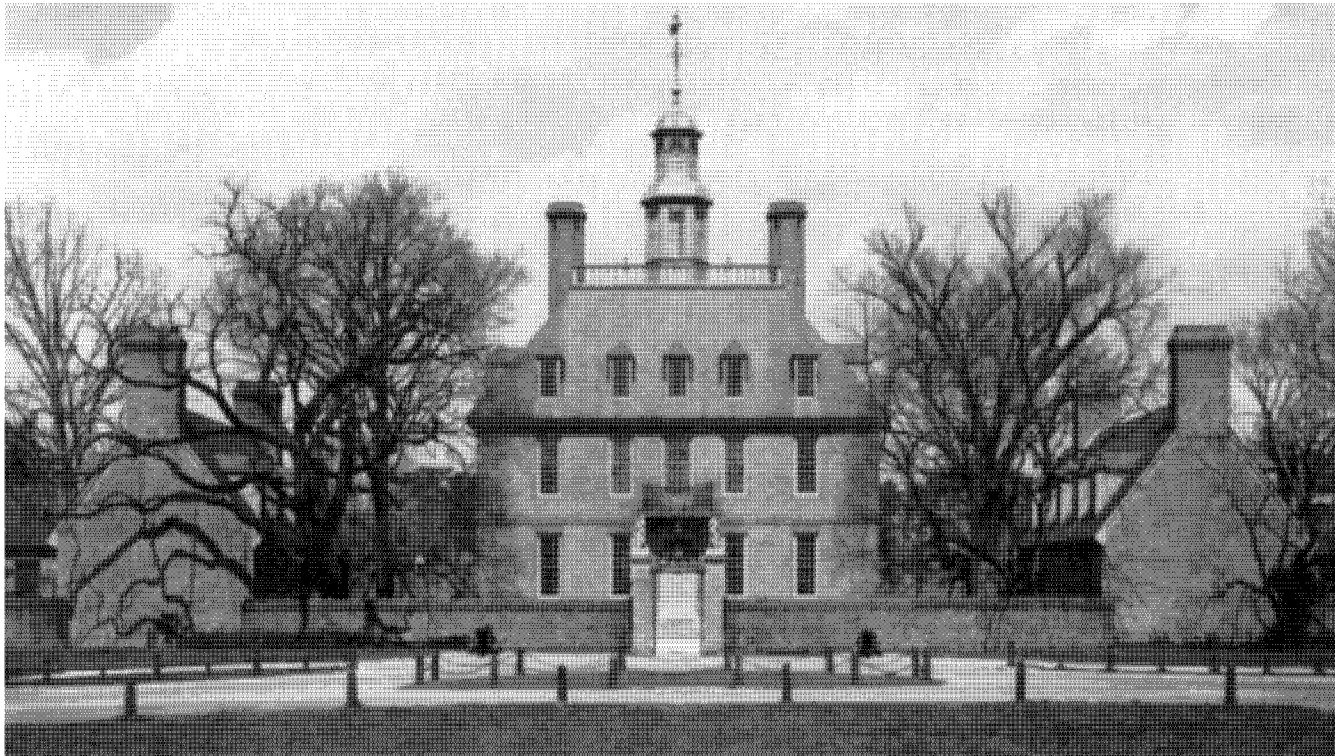
In the 1930s reconstruction of the 18th century Governor's Palace at Colonial Williamsburg, Virginia, the archeological remains of the brick foundation were carefully preserved in situ, and serve as a base for the reconstructed walls.

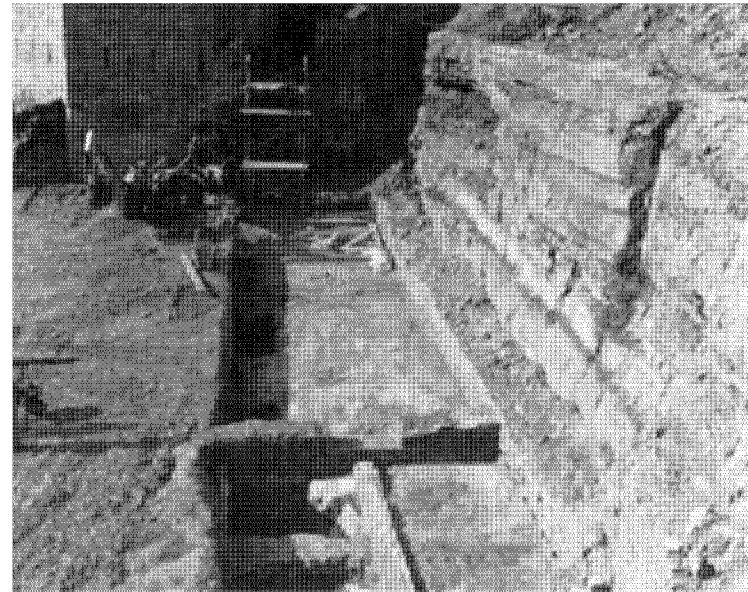
Reconstruction should generally be based on an extensive archeological investigation, as was done here to re-create a non-surviving commissary building at Fort Snelling.

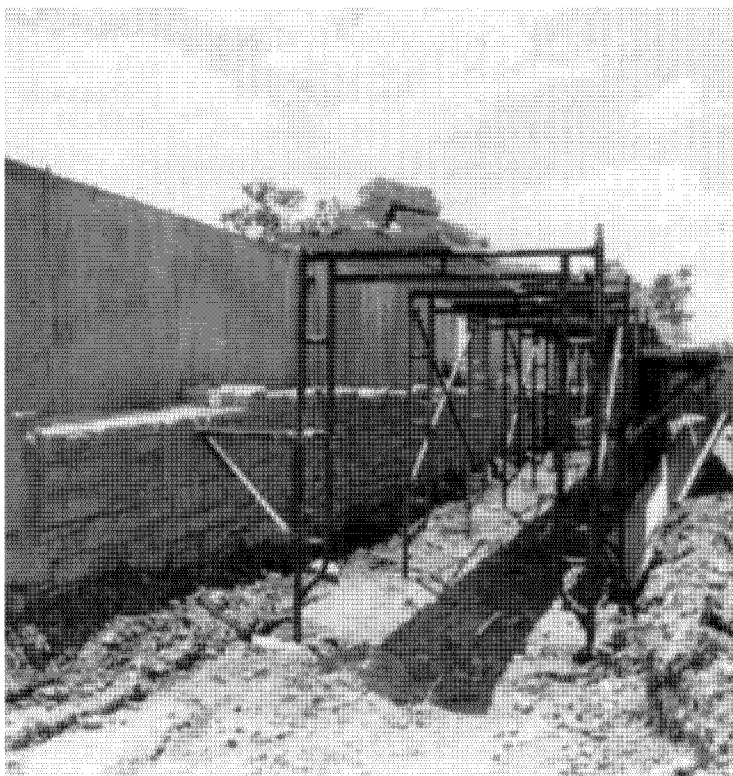
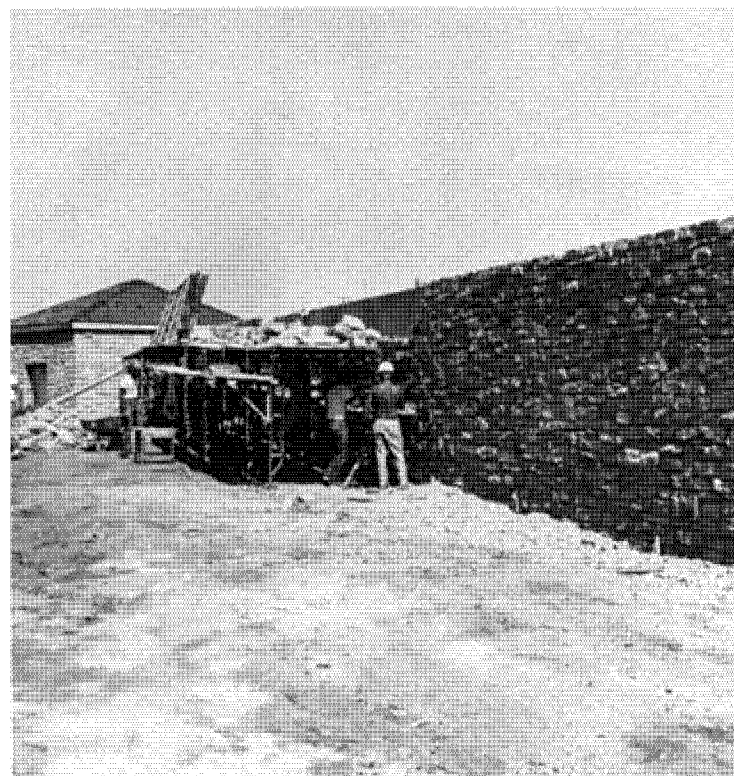
(a) and (b). Two photos illustrate the use of contemporary construction materials and techniques within the treatment, Reconstruction. Because Reconstruction is employed to portray a significant earlier time, usually for interpretive purposes, substitute materials may be appropriate if they are able to convey the historic appearance.

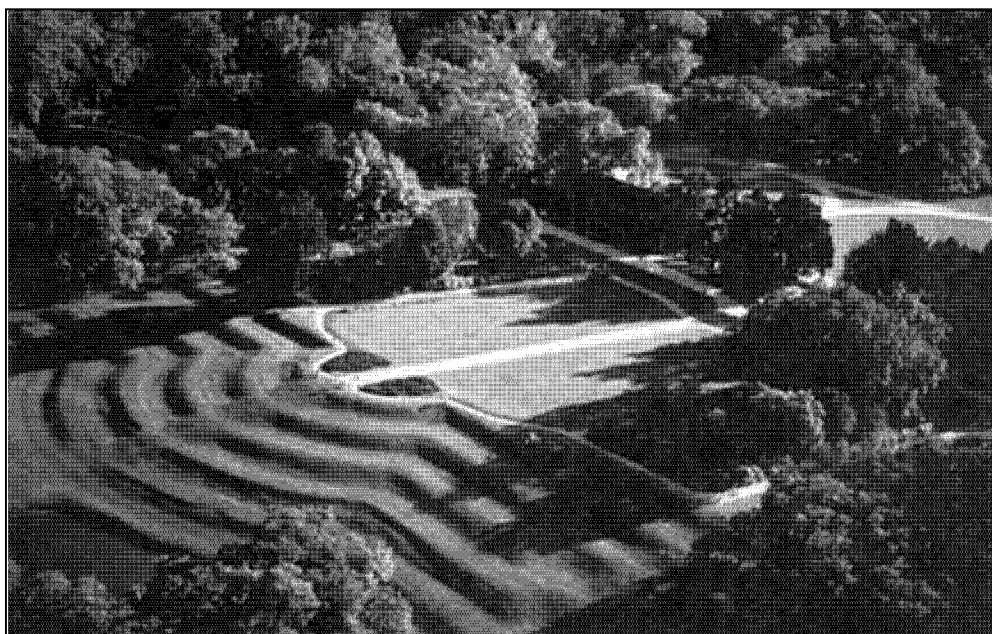
The spacious grounds at Middleton Place, near Charleston, South Carolina, constitute the first landscaped garden in America. The molded terraces, originally constructed in the 18th century, were largely reconstructed in the early 20th century based on extant remains and other documentary evidence. Photo: Middleton Place.

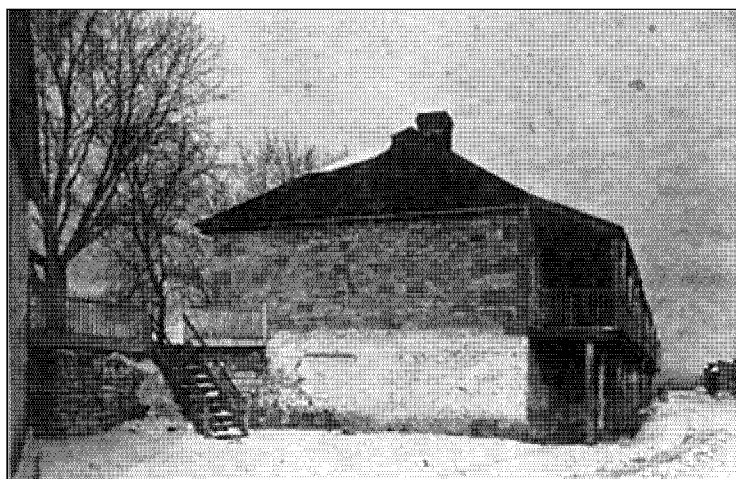
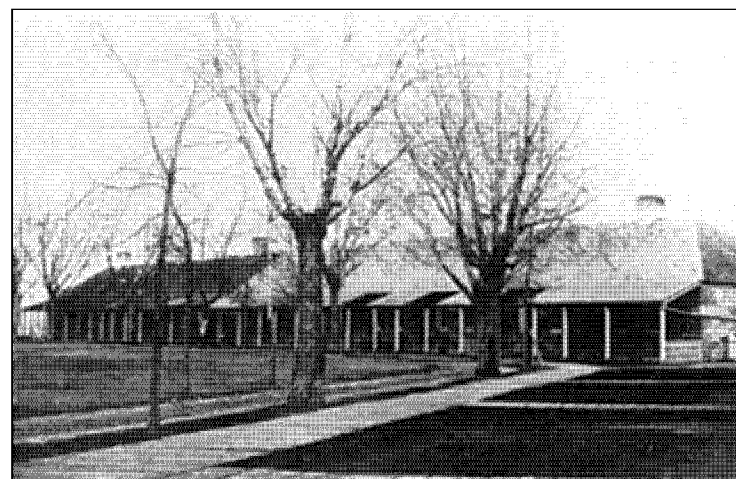
(a) and (b). Two views of the Officers' Quarters at Fort Snelling (ca. 1885 to 1900) not only provide information on the materials and form of the historic block, they document the wooden walkways and other landscape features such as stairs, railings, and tree placement. Historical and pictorial evidence would need to be combined with specific physical evidence in order to make the case for Reconstruction as a treatment.

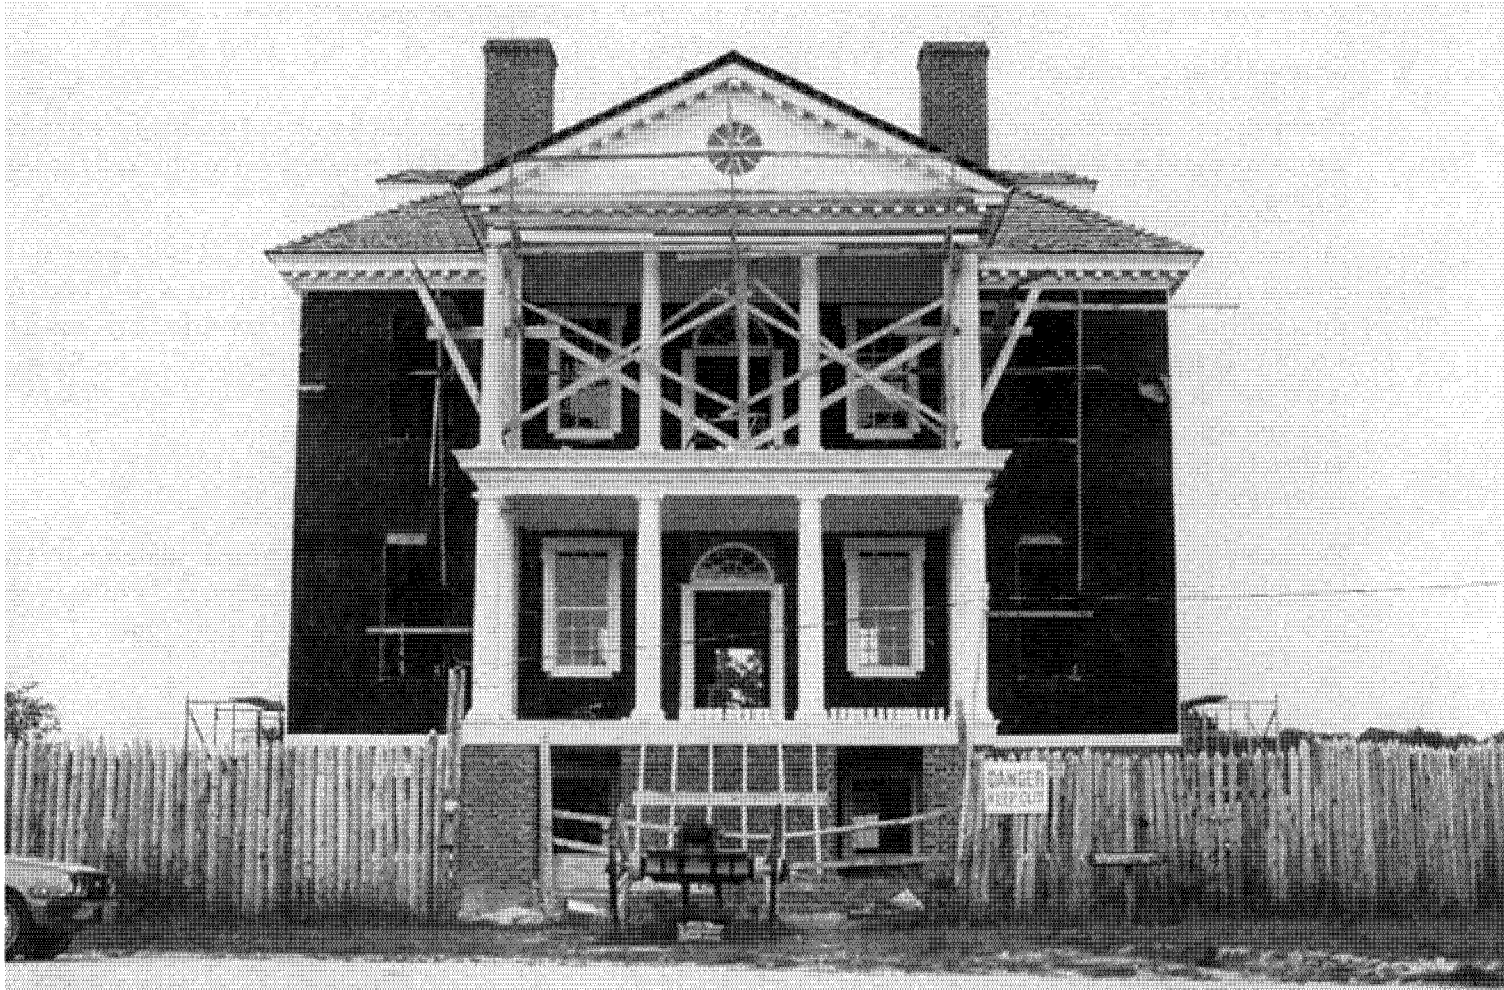
The 1778 Kershaw House, which served as British Headquarters during the Revolutionary War, was burned by Union troops in 1865. In the early 1970s, the house was reconstructed as part of Camden Battlefield, Camden, South Carolina. Built expressly for interpretive purposes, it serves as an illustrative reminder of a past event of national significance. The Standards for Reconstruction call for any re-created building to be clearly identified as a contemporary depiction. This is most often done by means of an exterior sign or plaque, or through an explanatory brochure or exhibit. A guide may inform visitors as well. Photo: Richard Frear.
